**DEPARTMENT OF TRANSPORTATION****DIVISION OF ENGINEERING SERVICES**

Contract #: 04-0120F4Cty: SF/ALA Rte: 80 PM: 13.2/13.9File #: 1.28**WELDING INSPECTION REPORT****Resident Engineer:** Casey, William**Address:** 333 Burma Road**City:** Oakland, CA 94607**Report No:** WIR-027700**Date Inspected:** 04-Jun-2012**Project Name:** SAS Superstructure**OSM Arrival Time:** 700**Prime Contractor:** American Bridge/Fluor Enterprises, a JV**OSM Departure Time:** 1730**Contractor:** American Bridge/Fluor Enterprises, a JV**Location:** Job Site

<b>CWI Name:</b>	Jesse Cayabyab and Bernie Docena			<b>CWI Present:</b>	<b>Yes</b>	<b>No</b>	
<b>Inspected CWI report:</b>	<b>Yes</b>	<b>No</b>	<b>N/A</b>	<b>Rod Oven in Use:</b>	<b>Yes</b>	<b>No</b>	<b>N/A</b>
<b>Electrode to specification:</b>	<b>Yes</b>	<b>No</b>	<b>N/A</b>	<b>Weld Procedures Followed:</b>	<b>Yes</b>	<b>No</b>	<b>N/A</b>
<b>Qualified Welders:</b>	<b>Yes</b>	<b>No</b>	<b>N/A</b>	<b>Verified Joint Fit-up:</b>	<b>Yes</b>	<b>No</b>	<b>N/A</b>
<b>Approved Drawings:</b>	<b>Yes</b>	<b>No</b>	<b>N/A</b>	<b>Approved WPS:</b>	<b>Yes</b>	<b>No</b>	<b>N/A</b>
				<b>Delayed / Cancelled:</b>	<b>Yes</b>	<b>No</b>	<b>N/A</b>
<b>Bridge No:</b>	34-

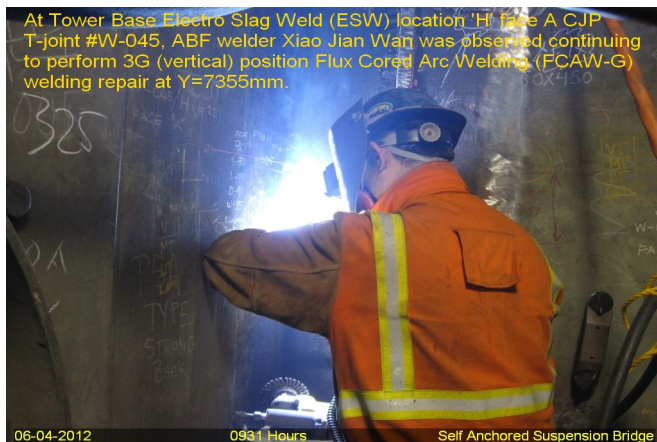
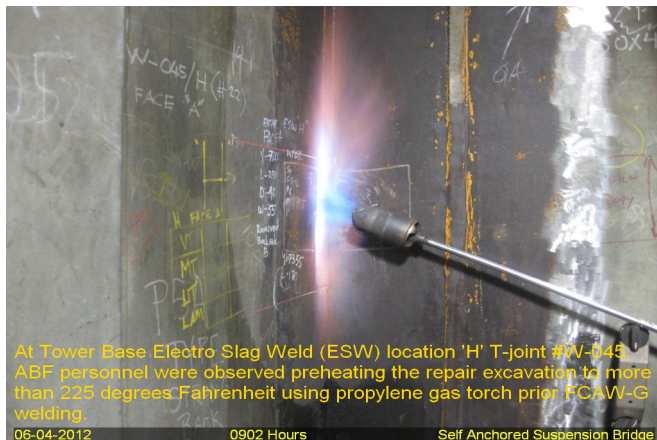
At Tower Base Electro Slag Weld (ESW), QA randomly observed ABF/JV qualified welder Xiao Jian Wan continuing to perform CJP groove welding repair. The welder was observed manually welding in the 3G (vertical) position utilizing the dual shielded Flux Cored Arc Welding (FCAW-G) with E71T-1M, 1/16" diameter wire electrode and implementing Caltrans approved Welding Procedure Specification (WPS) ABF-WPS-D15-3000-3 repair. The repair excavation was preheated and continuously maintained to more than 325 degree Fahrenheit using Miller Proheat 35 Induction Heating System prior/during welding. The ESW repair being welded was located at ESW 'H' face A from Y=7355mm and it was verbally approved by ABF QC Manager Jim Bowers according to ABF Lead QC Bonifacio Daquinag. During the shift, ABF QC Jesse Cayabyab was noted monitoring the welder with measured working current of 260 amperes, 23.0 volts with travel speed of 170mm per inch. At the end of the shift, 3G FCAW-G repair welding at location mentioned above was completed. Listed below was the first time repair being welded during the shift;

At Tower Base Electro Slag Weld (ESW), QA randomly observed ABF/JV qualified welder Lou Xiao Hua perform CJP groove welding cover repair. The welder was observed manually welding in the 3G (vertical)

position utilizing Shielded Metal Arc Welding (SMAW) with 3.2mm diameter E70018H4R electrode and implementing Caltrans approved Welding Procedure Specification (WPS) ABF-WPS-D15-1000 Repair. The ESW weld covers being repaired which are located at ESW 'P' transition butt joint N-043 below the 9 meter diaphragm are having excavations with less than five (5) mm depth that were rejected due to visual defects and Magnetic Particle Testing (MT) indications. Prior welding, the welder was noted preheating the plate to more than 300°F using propylene gas torch and was verified by ABF QC Bernie Docena. QC was also noted monitoring the parameters of the welder with measured working current of 120 amperes on the 3.2mm diameter E7018H4R.

At Tower Base 13 meter external diaphragms, this QA noted ABF personnel continuing to grind the welded cover of West and South external diaphragms W110 and W111 respectively in preparation for the Visual Test (VT) and the Magnetic Particle Testing (MT) to be performed by ABF QC and QA. During the shift, ABF QC Bernie Docena was noted monitoring the various activities being performed by ABF personnel. At the end of the shift, grinding of various corner stiffeners and flush grinding on the weld cover of PJP T-joints W110 and W111 were still continuing. ABF welder Han Wen Yu was also noted performing touch up SMAW welding on the weld covers of W110 and W111 due to underfill and surface profile. After the completion of the touch up repair on the two PJP T-joints mentioned, the same welder also performed weld cover repair on the corner stiffeners W139-2 and W140-2 due to excessive undercut. All the welds that were cover repaired were preheated to 225°F using propylene gas torch prior welding. At the end of the shift, SMAW weld cover repair was still continuing and should remain tomorrow.
